## North Coast Regional Water Quality Control Board

### **Inspection Report for September 18, 2019 Warrant Inspection, Humboldt County Assessor's Parcel Number 211-361-007-000**

File: Cannabis Program Inspections, Humboldt County, September 2019  
HCSO/Green Wave Humboldt County Inspections, Paul Thompson,  
CIWQS Place ID 861375

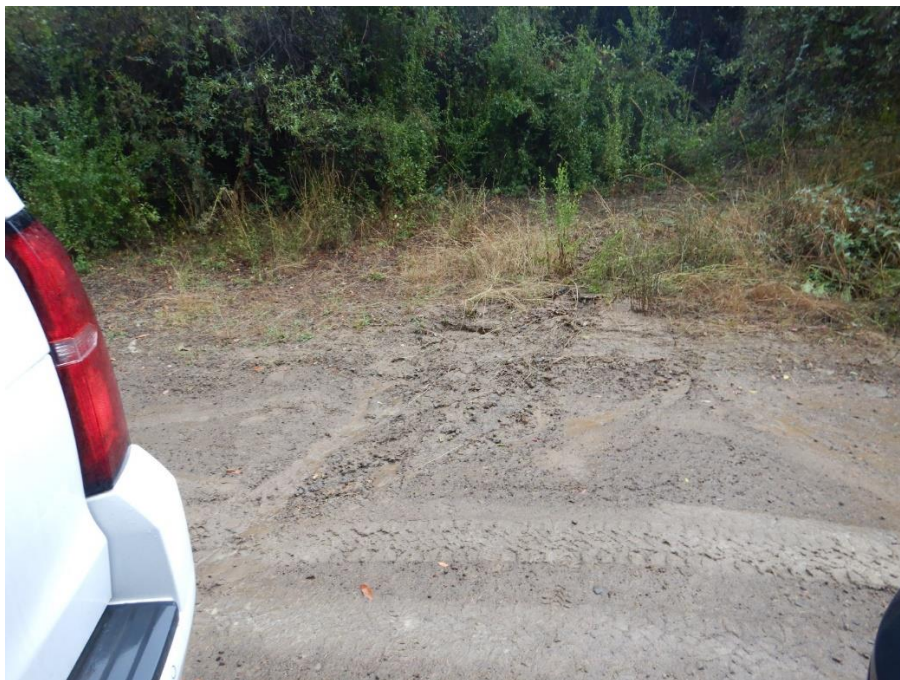
On September 18, 2019, I inspected the above-referenced property. Figure 1, above, shows inspection points discussed below. I accessed the property from the west and parked at WQ 1. It was raining lightly and I observed stormwater entering the road from the east (Photo 1) and flowing over the edge of the road to the west (Photo 2). I walked south and observed more stormwater flowing from the east at WQ 2 (Photo 3) and past loosely contained refuse to the west (Photo 4). I walked up another road and observed stormwater running off the road in the direction of WQ 1 (Photo 5) and a 350-foot length of hydrologically-connected road upstream from this location to WQ 3 (Photo 6).

| <i>Map point</i> | <i>Feature</i> | <i>Brief Description</i> | <i>Water Quality Concern</i> | <i>Associated Photo(s)</i> |
|--|--|--|---|---|
| WQ 1,<br>WQ 2,<br>WQ 3,<br>WQ 5,<br>and<br>WQ 10 | Deficient road drainage | Stormwater flows down road surfaces for lengths as long as 350 feet without interruption. | Threatened discharge of waste to receiving waters | Photo 1 through Photo 6, Photo 9 and Photo 16 |

*Photo 1—Looking east at stormwater flowing across road at WQ 1*

1. Retain a licensed professional to inventory, assess, and develop a workplan and schedule to implement measures to ensure that all developed features, roads, and cultivation areas throughout the Property are corrected, restored, and/or maintained in conditions that prevent or minimize erosion, sediment transport/delivery, and adverse impacts to water quality and beneficial uses. Include measures to ensure that unstable features caused or affected by onsite development and operations are removed or otherwise protected so as to minimize the potential for these features to cause adverse impacts to water quality and beneficial uses. Dispose of all development and restoration-related earthen spoils in a manner to prevent/minimize transport and delivery to receiving waters

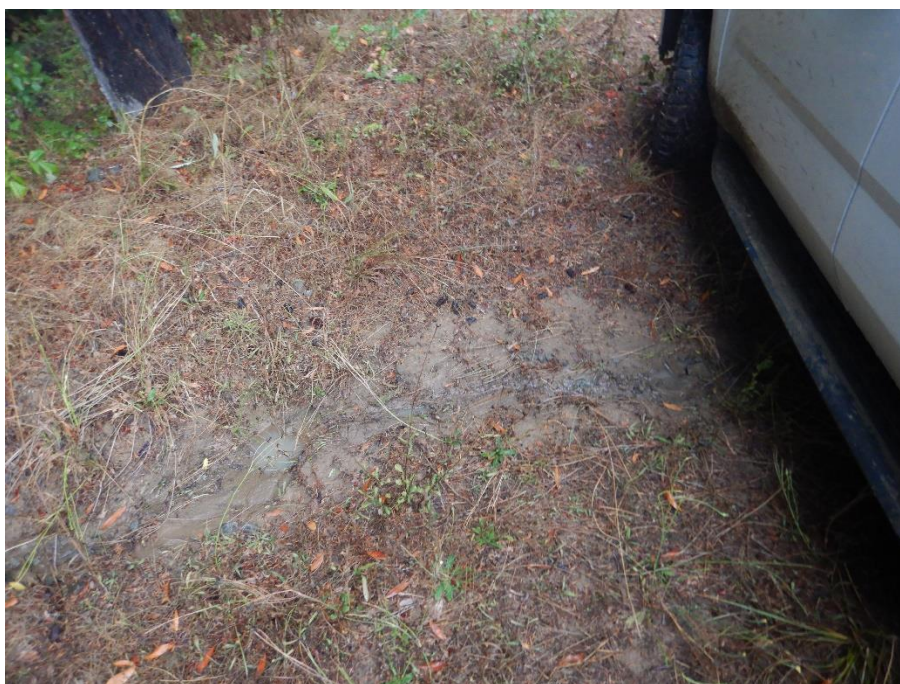
*Photo 2—Water pictured in previous image before it flows off the road.*

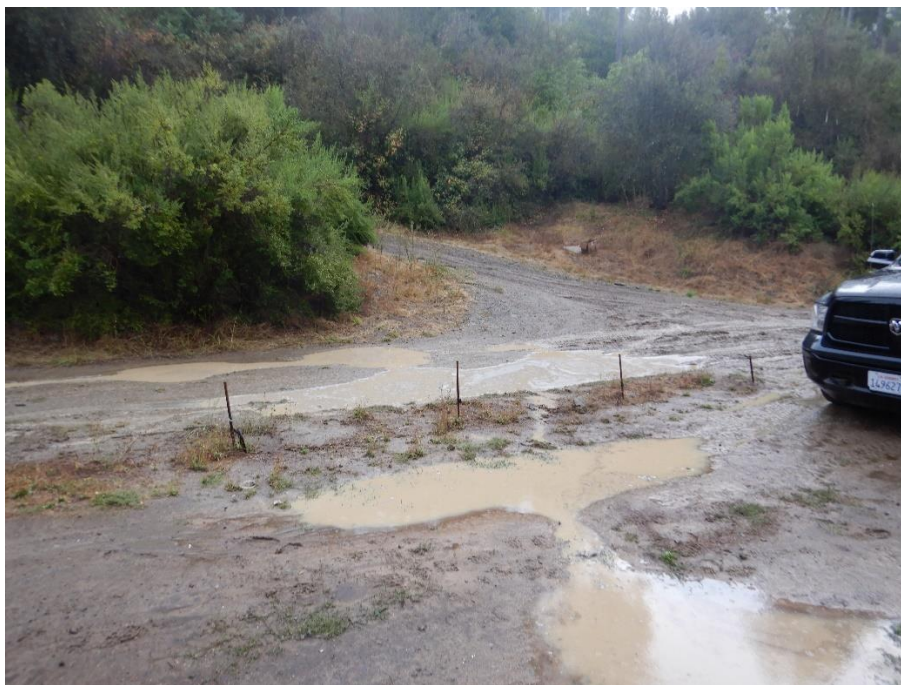
*Photo 3— Looking east at stormwater flowing across road at WQ 2.*

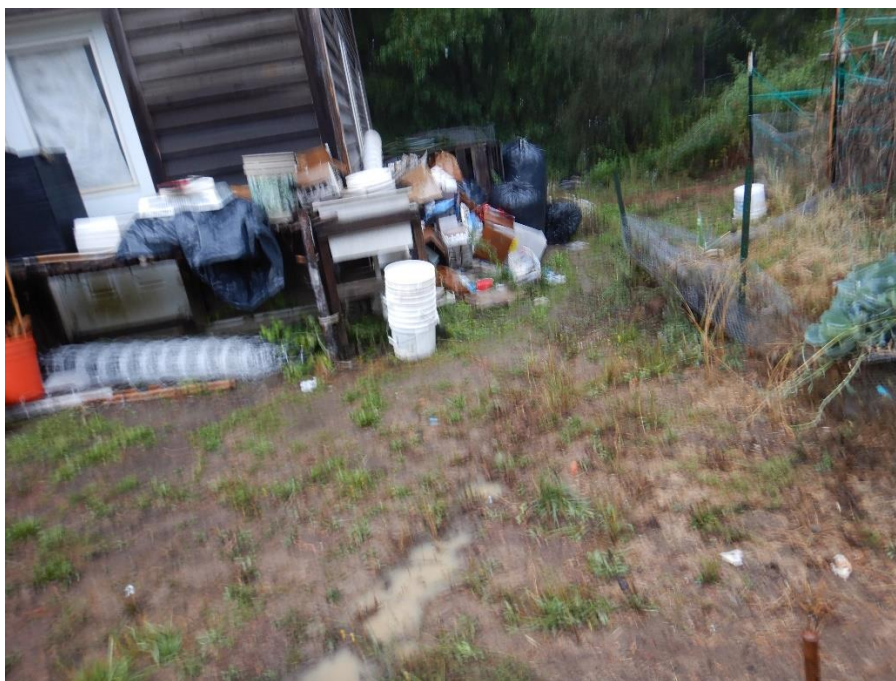
| <i>Map point</i> | <i>Feature</i> | <i>Brief Description</i> | <i>Water Quality Concern</i> | <i>Associated Photo(s)</i> |
|--|--|--|---|---|
| WQ 2 | Refuse | Refuse is loosely contained in and adjacent to the path of concentrated stormwater flow. | Threatened discharge of waste to receiving waters | Photo 4 |

11. Refuse and human waste: Stormwater flows past refuse at WQ 2. The pit-toilet at WQ 20 was the only location that I observed for collecting human waste. The bathing area south of WQ 2 discharges to the road, which is hydrologically-connected to the riparian area adjacent to Sonoma Creek.

*Photo 4—Looking west from WQ 2 where stormwater pictured in previous image flows past refuse before continuing down the hillside.*

5. Collect and dispose of or contain all refuse and cultivation-related wastes in a location and manner so as to minimize potential for these wastes to enter or be transported into receiving waters.

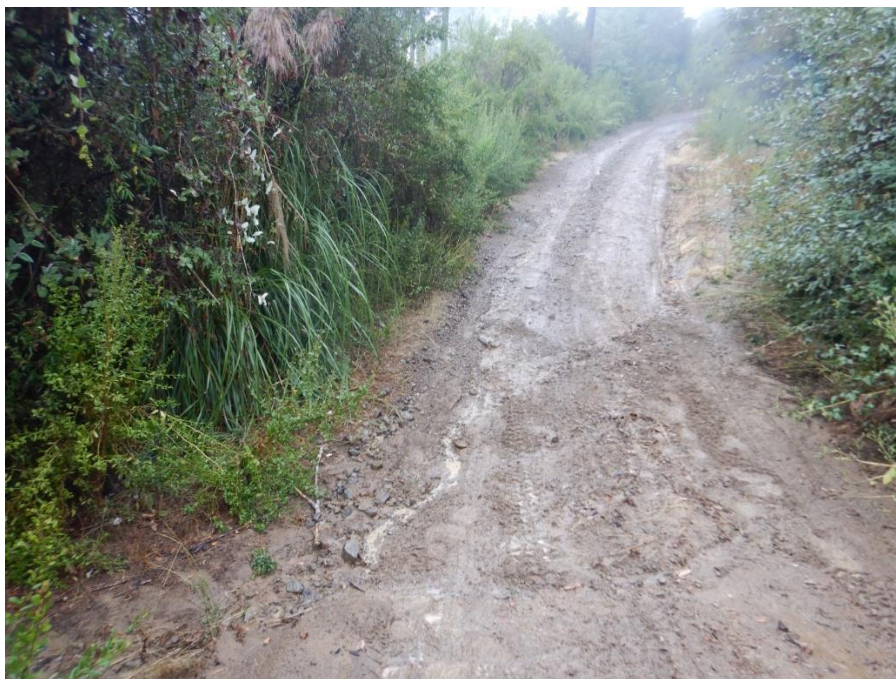
*Photo 5— Looking north along the switchbacks east of WQ 1. Stormwater from WQ 3 flows down the road surface, exits the road in the lower left of the image and continues to WQ 1.*

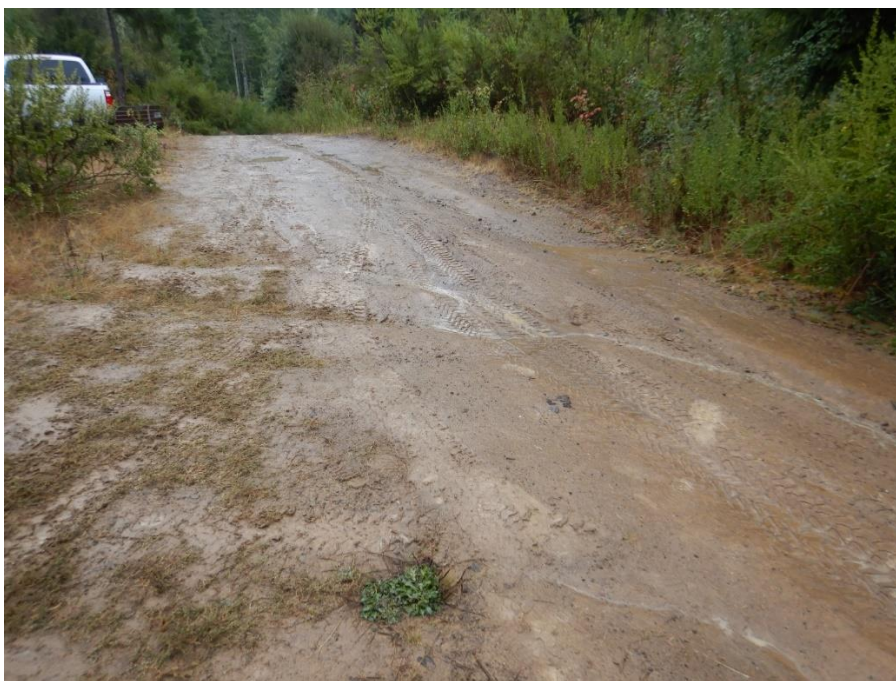
*Photo 6—Looking north at WQ 3. The picture shows the break in slope of the road where hydrologic connectivity with WQ 1 begins.*

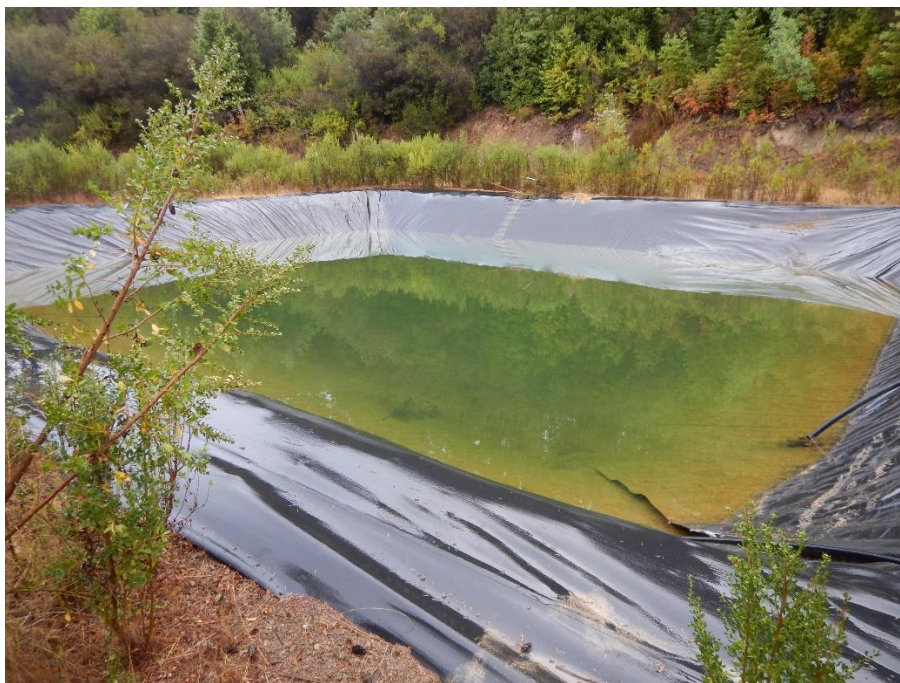
At the top of the road I observed a lined reservoir at WQ 4 (Photo 7) with no apparent outlet and a seep or spring at the east side (Photo 8). I estimated the wetted area of the reservoir was 7,000 square feet and the reservoir-full depth was 20 feet. South of the reservoir, I observed stormwater flowing down a 150-foot road segment at WQ 5 (Photo 9). I observed two greenhouses, each approximately 2,500 square feet, at WQ 6 (Photo 10). I observed a reservoir at WQ 7 (Photo 11) with an outflow pipe that discharges towards a suspected tributary to Sonoma Creek (Photo 12).

| <i>Map point</i> | <i>Feature</i> | <i>Brief Description</i> | <i>Water Quality Concern</i> | <i>Associated Photo(s)</i> |
|--|--|--|---|---|
| WQ 4 | Reservoir | Recently constructed reservoir has no outfall | Threatened discharge of waste to receiving waters | Photo 7 and Photo 8 |

Roads are hydrologically-connected for long distances, resulting in scouring by stormwater. The rolling dip north of the crossing at WQ 9 requires maintenance to effectively divert water. The reservoir at WQ 4 does not appear to have a means for managing the water surface elevation other than the irrigation diversion lines.

*Photo 7—Looking northeast at the lined reservoir located at WQ 4. The reservoir has no apparent outlet.*

6. In the case that the landowner intends to keep or replace the impoundments observed at location WQ 4 and WQ 7, ensure that the assessment described under recommendation 1., above, includes review by an appropriately qualified, licensed professional, certifying that the impoundments meet, or specifying necessary work to ensure that the impoundments will meet the following standards:

- a. Interior and exterior embankment slopes are no steeper than a 2:1 ratio
  - b. 90% compaction of earthen slopes
  - c. The reservoir must have a liner. If a geosynthetic membrane liner is deemed unacceptable for biological resources, then a proper dry bentonite application may be proposed, including specifications and oversight on bentonite amount, application, mix with soil, hydration, and compaction.

- d. The impoundment must have no discernible cracks in any portion of the berm.
  - e. The impoundment must be designed, constructed, and maintained to ensure a 2-foot elevational freeboard above the outlet structure.

- f. The outlet structure must have a minimum capacity adequate to accommodate the expected 100-year peak inflow plus debris.
  - g. A stability analysis must demonstrate that the factor of safety for the critical slope is at least 1.5 under dynamic conditions and include a description of the method used to calculate the factor of safety and a description of the assumptions used in the stability analysis.

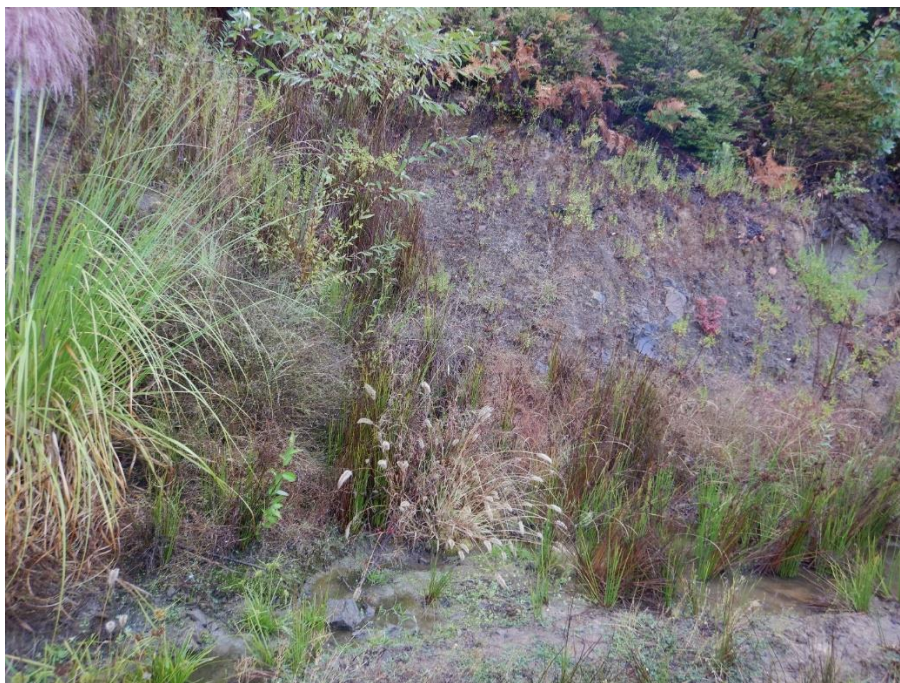
*Photo 8—Looking at the cut-bank on the eastern side of the reservoir at WQ 4. Ground water is seeping from the bank and the plant species juncus is growing.*

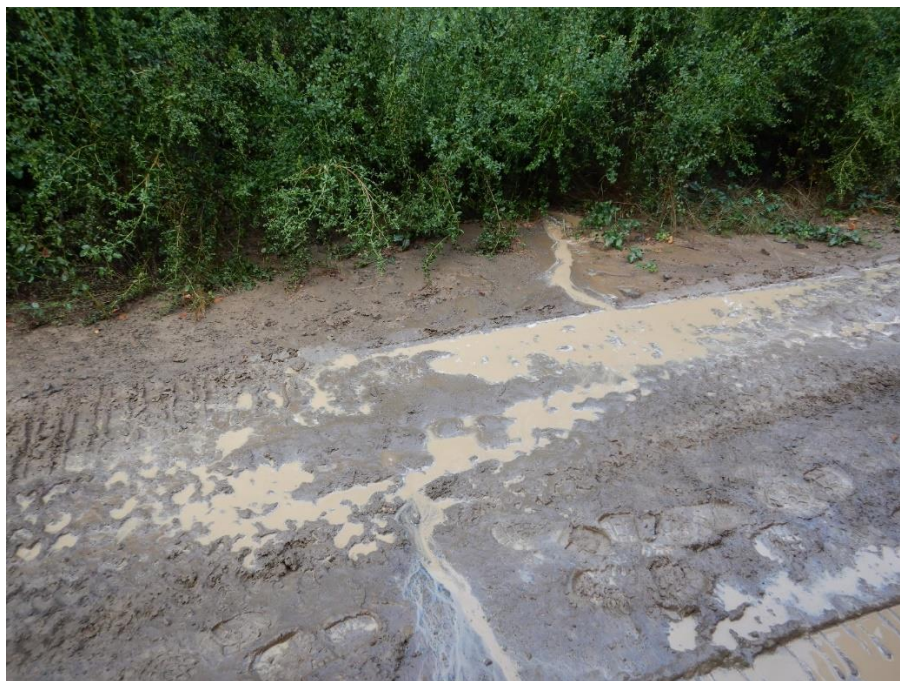
*Photo 9—Picture shows stormwater flowing off of the road at WQ 5.*

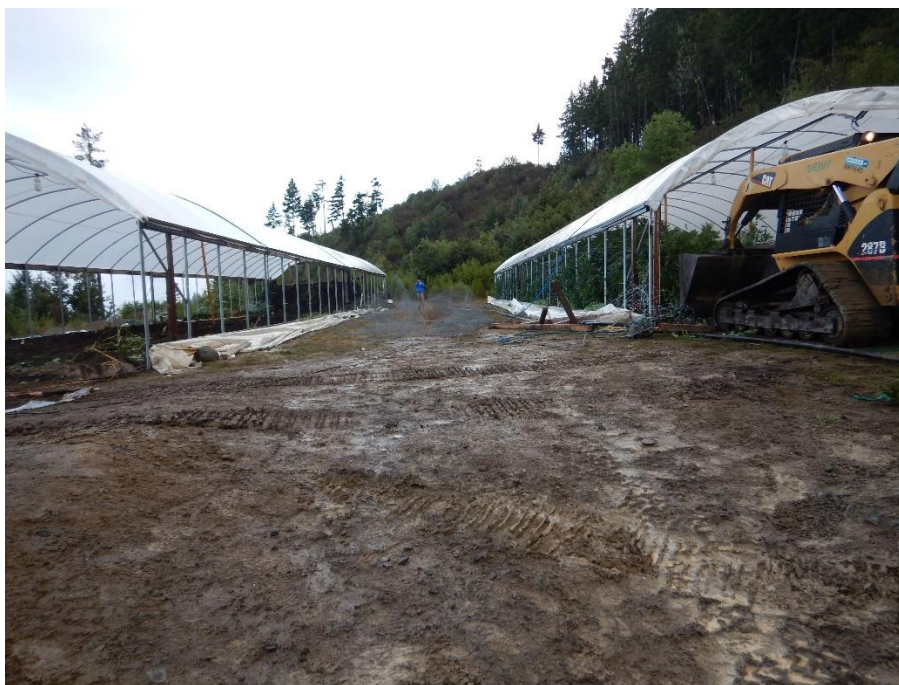
| <i>Map point</i> | <i>Feature</i> | <i>Brief Description</i> | <i>Water Quality Concern</i> | <i>Associated Photo(s)</i> |
|---|---|---|--|---|
| WQ 6 and WQ 10 | Cannabis cultivation areas | Approximately 9,000 square feet of cannabis cultivation in hoop houses. | Cannabis cultivation/discharge of waste without a report of waste discharge and/or coverage under State Water Board regulatory order | Photo 10 and Photo 17 |

*Photo 10—Looking north from WQ 6 at an area between two greenhouses used for cannabis cultivation. The greenhouses are approximately 2,500 square feet each.*

2. If the property owner and/or tenant(s) choose to continue to cultivate cannabis, enroll for coverage under and take steps to comply with the requirements of the Statewide General Order (Order WQ 2019-0001-DWQ, General Waste Discharge Requirements and Waiver of Waste Discharge Requirements for Discharges of Waste Associated with Cannabis Cultivation Activities). More information about the

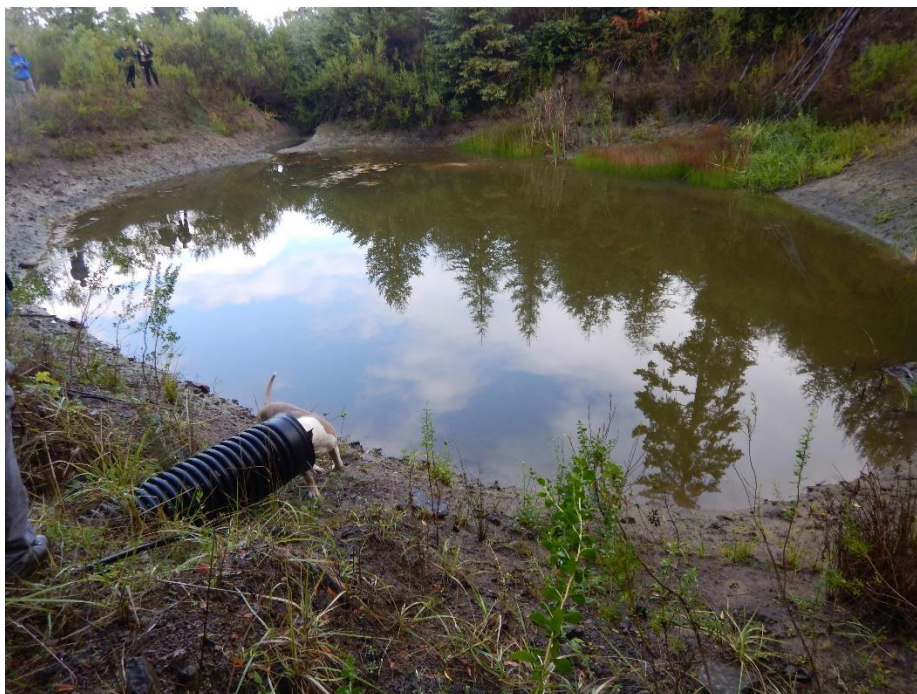
| <i>Map point</i> | <i>Feature</i> | <i>Brief Description</i> | <i>Water Quality Concern</i> | <i>Associated Photo(s)</i> |
|--|--|--|---|---|
| WQ 7 | Reservoir | Reservoir does not have a liner and discharges towards a suspected tributary to Sonoma Creek | Threatened discharge of waste to receiving waters | Photo 11 and Photo 12 |

*Photo 11— Looking north at reservoir located at WQ 7. The reservoir outlet is in the front left of the image.*

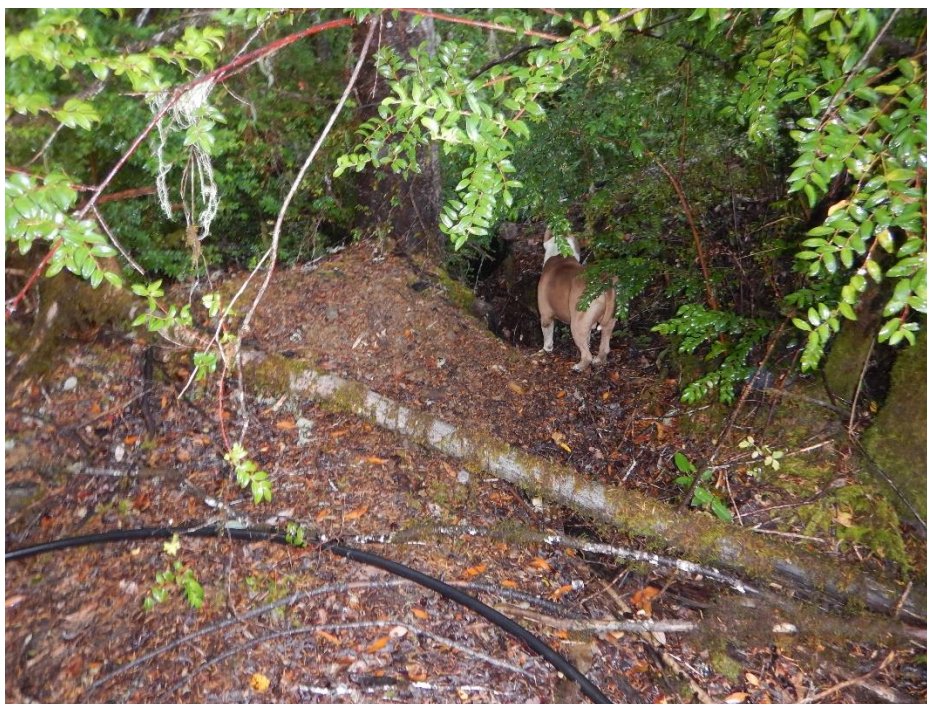
I did not investigate the conditions between the reservoir outlet at WQ 8 and the suspected tributary to Sonoma Creek. The dischargers should ensure that polluted water from the reservoir is not discharged into the creek. I did not observe water quality concerns associated with where the cultivation areas were located relative to water course and wetlands.

*Photo 12—Looking south from WQ 8, towards the direction of the outlet for the reservoir pictured in the previous image. The outlet discharges into a suspected tributary to Sonoma Creek.*

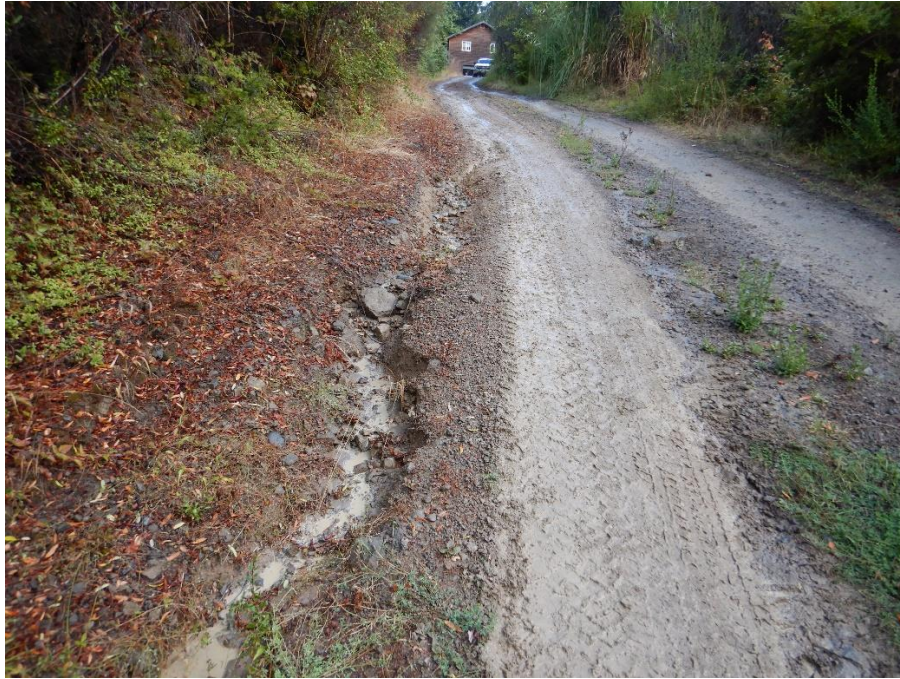
| <i>Map point</i> | <i>Feature</i> | <i>Brief Description</i> | <i>Water Quality Concern</i> | <i>Associated Photo(s)</i> |
|--|--|--|---|---|
| WQ 9 | Road Hydrologically-connected to riparian area | Approximately 400 feet of road are hydrologically-connected to area riparian to Sonoma Creek | Threatened discharge of waste to receiving waters | Photo 13 |

*Photo 13—Concentrated stormwater rilling road surface north of WQ 9. There was a critical dip before the crossing at WQ 9, however it has lowered over time and no longer intercepts stormwater flowing over the road surface.*

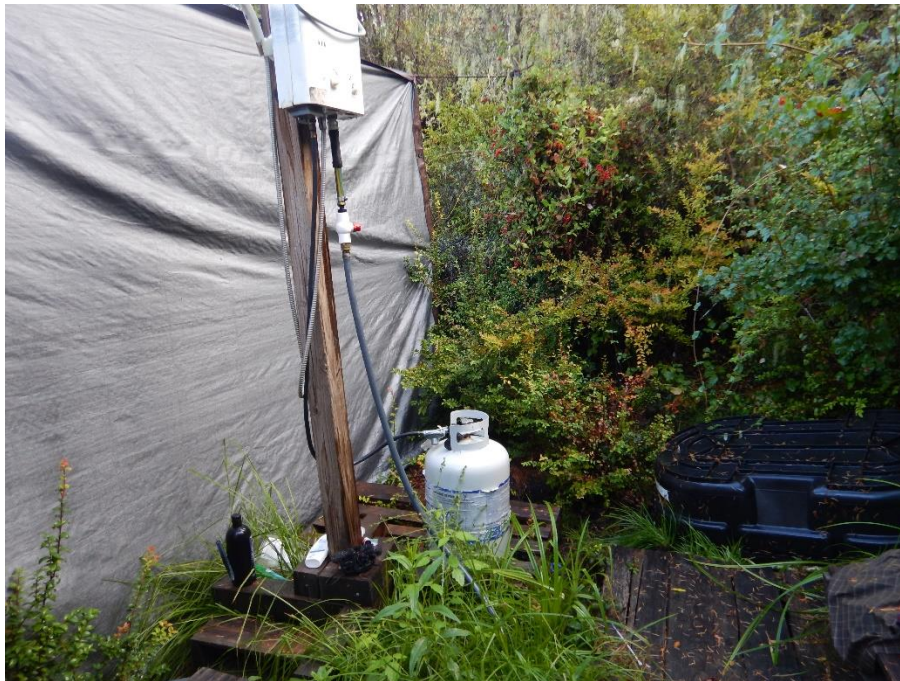
*Photo 14—Looking at a structure used for bathing approximately 400 feet north of WQ 9. Water from the structure may flow into the road and mix with stormwater before discharging to the riparian area adjacent to Sonoma Creek at WQ 9.*

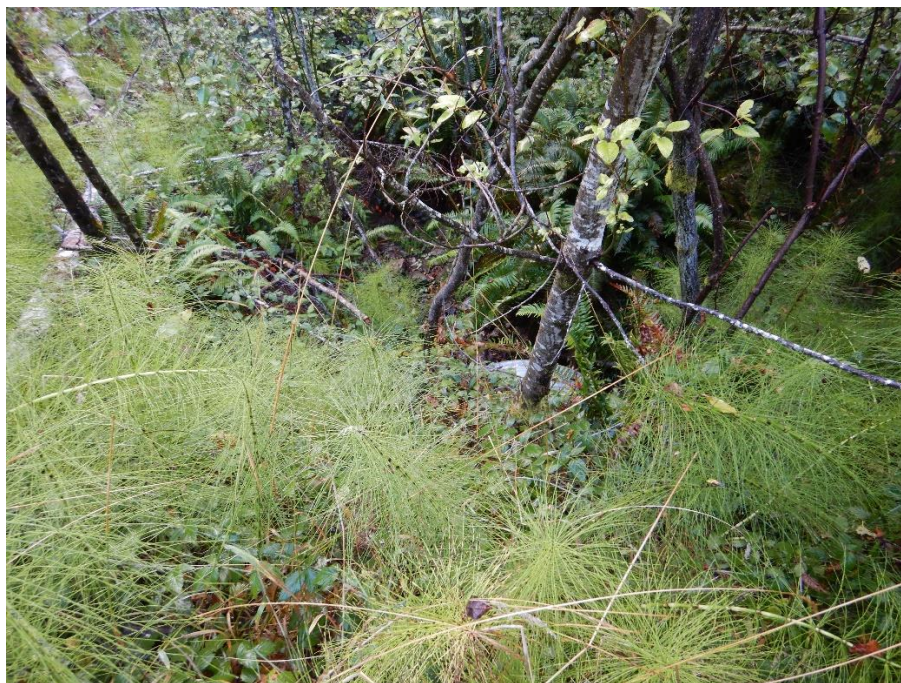
Other than the drainage issues associated with the road and discussed above, I did not observe any water quality issues associated with the stream crossing at WQ 9.

*Photo 15—Looking at an approximate 42" diameter corrugate metal culvert conveying Sonoma Creek below the road at WQ 9.*

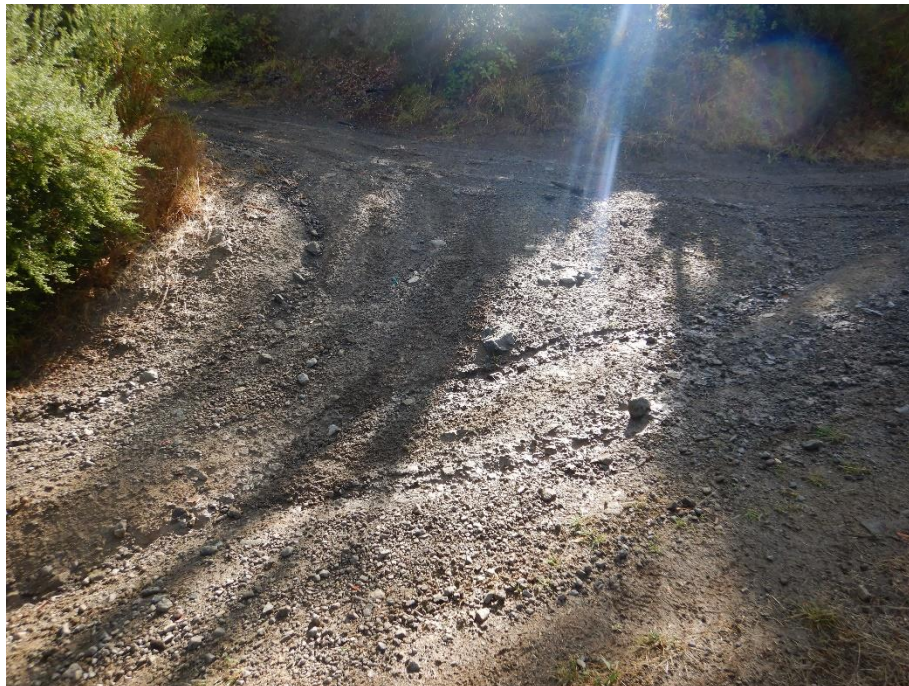
I walked back north along the same road and observed scour marks on a steep section of road (Photo 16) leading to another greenhouse at WQ 10 (Photo 17). I estimate the area of the greenhouse was 4,000 square feet. Northeast of the greenhouse I observed a pit toilet (Photo 18).

*Photo 16—Stormwater concentrating and scouring road surface east of WQ 10.*

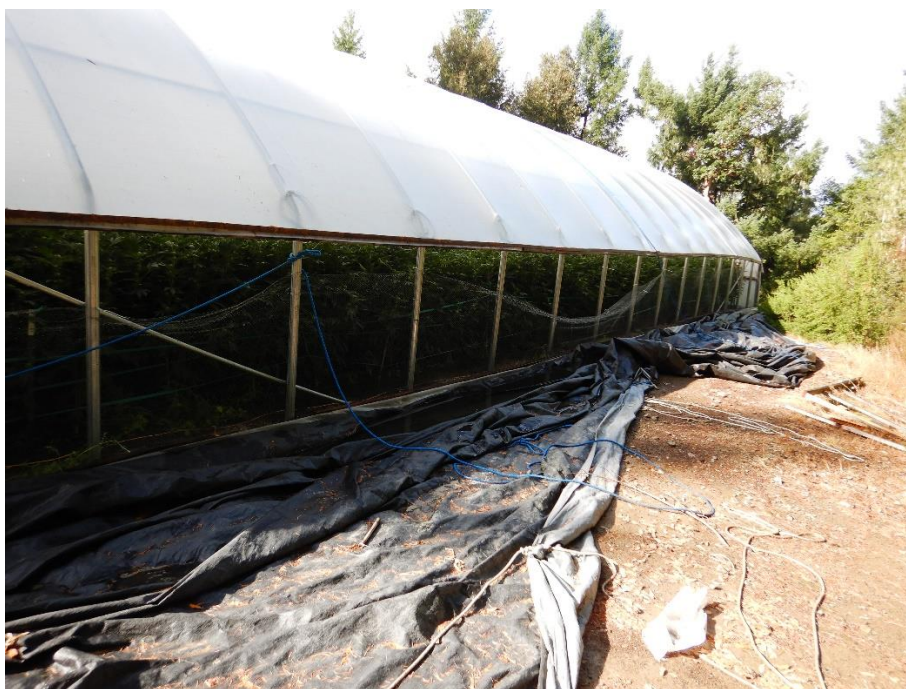
*Photo 17— Looking at an approximate 4,000 square foot greenhouse at WQ 10.*

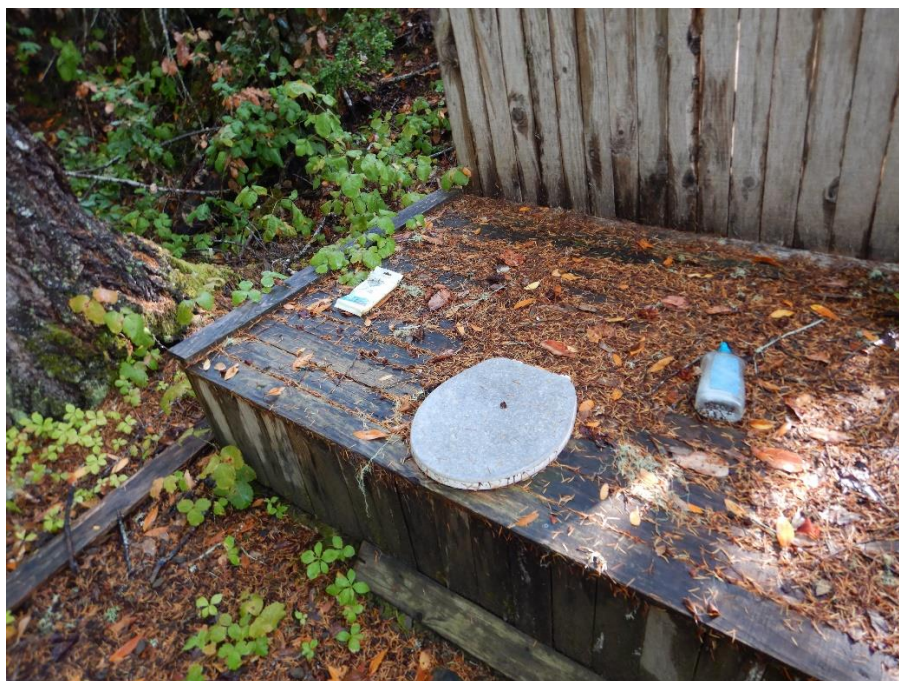
| <i>Map point</i> | <i>Feature</i> | <i>Brief Description</i> | <i>Water Quality Concern</i> | <i>Associated Photo(s)</i> |
|--|--|--|---|---|
| WQ 10 | Pit toilet | Toilet discharges waste to the ground. | Threatened discharge of waste to ground waters. | Photo 18 |

*Photo 18—A pit-toilet located in the vicinity of WQ 10.*

4. Discontinue use of and dismantle any outhouse/pit toilet features and work with Humboldt County to ensure that all domestic and human wastes are collected and disposed of consistent with applicable County requirements.
